Air Quality Systems East Africa

December 2025

Nairobi, Kenya

Executive Summary

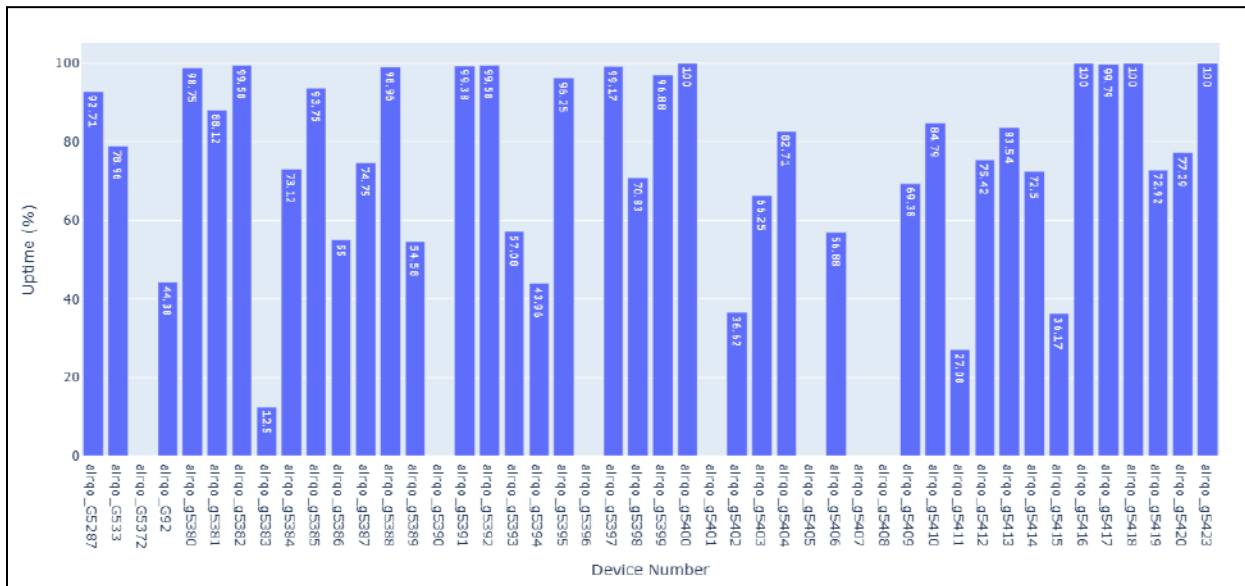
Figure 1. Network uptime trends before maintenance. This figure illustrates the device uptime two weeks before maintenance as a function of hours of the day with a record of entries transmitted by the device.

During the analysis period, 19 devices failed to meet the manufacturer's prescribed minimum uptime performance of 75%. Notably, seven of these devices were completely offline throughout the entire analysis period. The desk-based analysis focused on indicators of potential issues; for a comprehensive overview of the actual faults confirmed during subsequent site visits, please refer to Section 4 (Maintenance Activities) of this report.

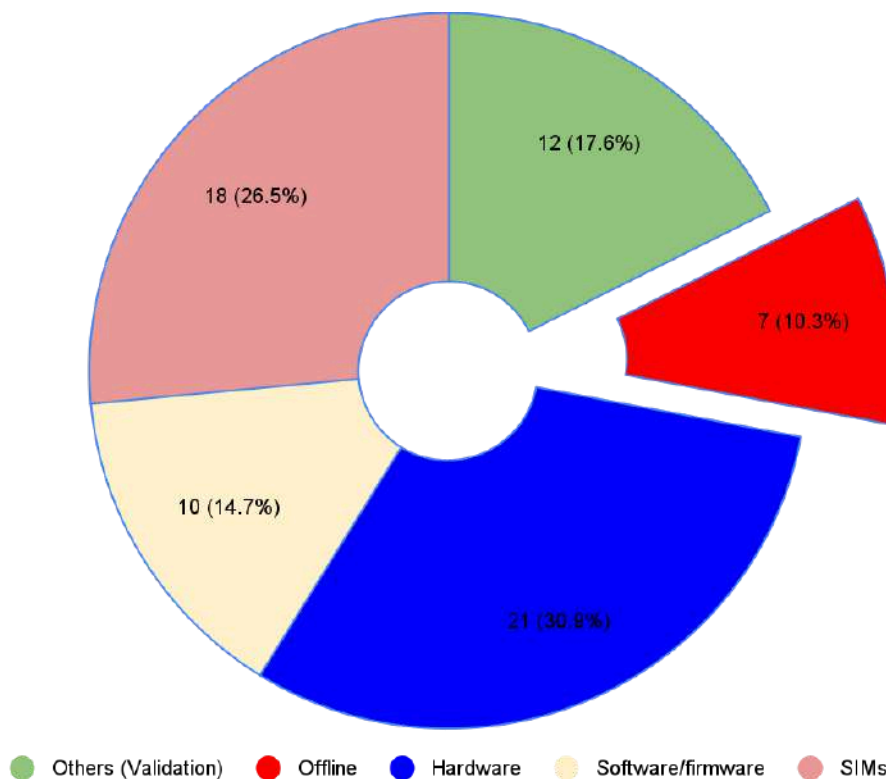
Figure 2. Categories of network issues. This figure shows the distribution of the recorded network issues as observed in the field. Note that some devices in the network had multiple issues and this count therefore does not reflect the total tally of locations visited.

technical classifications: hardware component malfunctions, accounting for 21 instances, primarily associated with SD card failure issues; communication/ GPRS network connectivity deficiencies, totaling 18 instances related to inconsistent data transmission; and 10 instances of software/firmware anomalies. To augment network consistency and operational resilience, several critical remedial actions were executed. These actions involved the deployment of the most recent firmware (ver_42.76), which incorporates enhanced EEPROM protection designed to improve the reliability of Firmware Over The Air (FOTA) updates; comprehensive replacement and/or reformatting of compromised SD cards; and the optimization of IOT SIM network profiles, specifically by designating Safaricom as the default roaming profile to ensure more dependable data transmission.

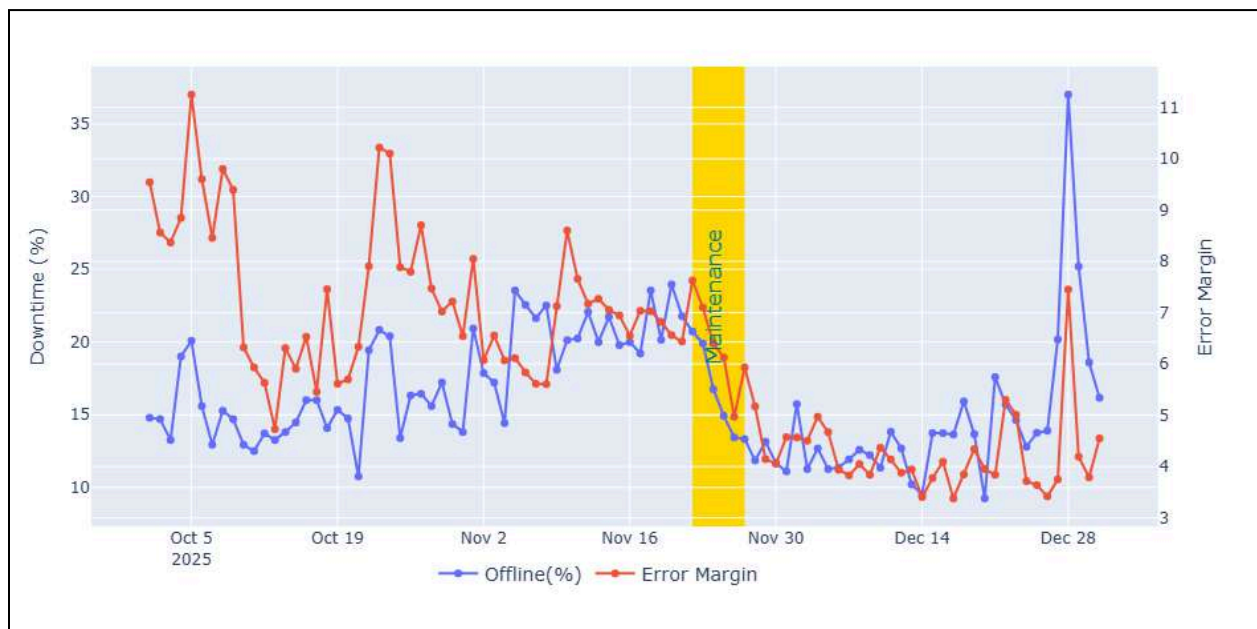
There is a clear and encouraging downward trend in the average weekly error margin throughout the entire quarter, starting from over $9\mu\text{g}/\text{m}^3$ in late September and consistently decreasing to around $4\mu\text{g}/\text{m}^3$ by late December. This suggests a continuous improvement in sensor data quality over time.

Figure 5. Average daily network downtime and intra-sensor error margin. The first axis of this figure illustrates the network daily offline status calculated as a percentage of hours in the day when a device fails to transmit a single data point. The second axis on the right is the mean intra-sensor error margin of the network computed as from the difference in readings between each of the two sensing elements onboard each device.

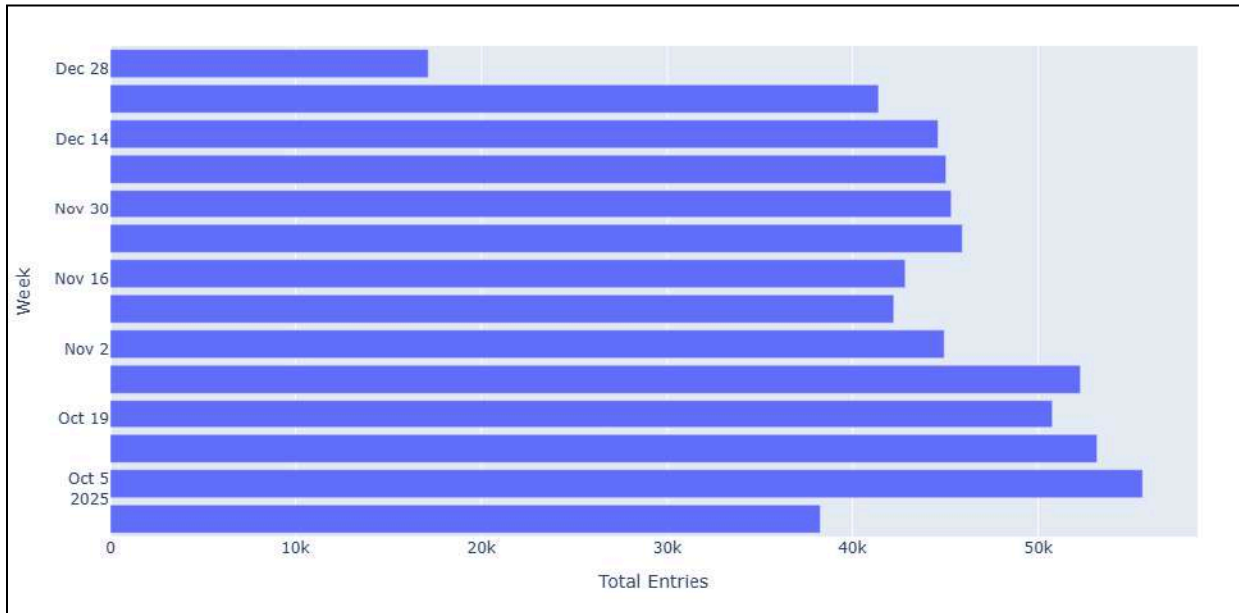
Correspondingly, the "Total Weekly Entries" (representing data completeness or activity) as shown in the figure 6 below experiences a noticeable dip during the maintenance week, followed by a strong recovery in the subsequent weeks, often surpassing pre-maintenance levels. This signifies a successful resumption of data collection.

Figure 6. Total weekly count of data entries recorded by the devices on the network. This figure shows a count of the weekly data points transmitted by the device in the 4th quarter of 2025. Note that a device is expected to post at least 1 entry every hour for it to be considered active on the network but ideal cases range from 6 to 30 entries per hour.

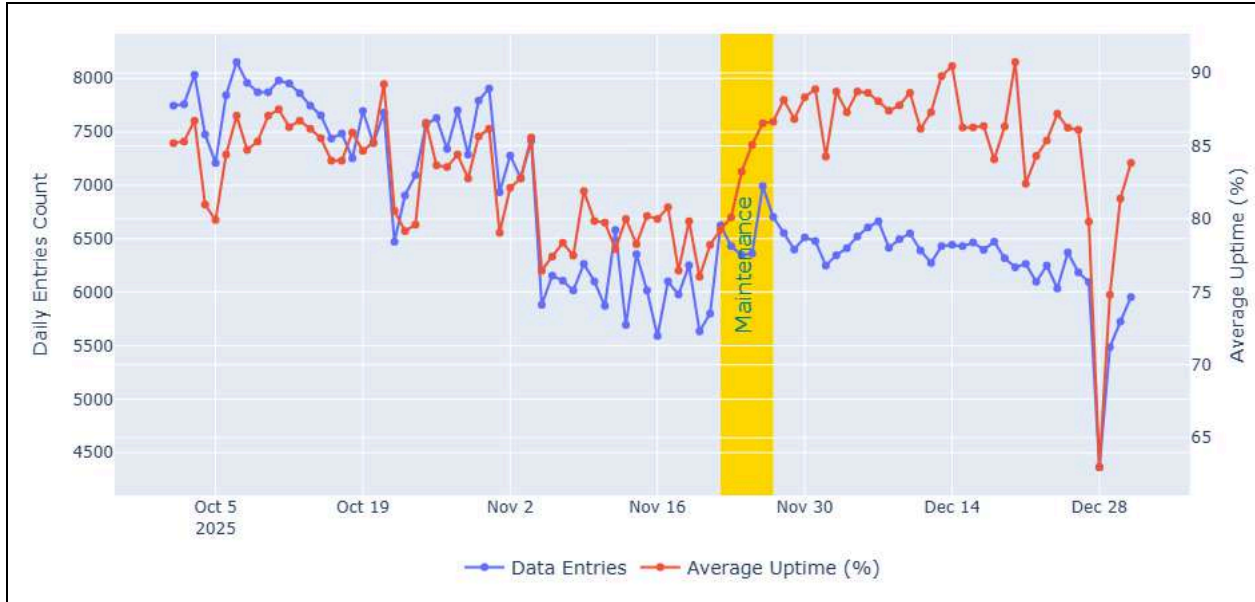
Figure 7. Average daily network uptime and total daily entries. The first axis of this figure illustrates the network daily count of entries transmitted by all active devices in the network. The second axis on the right is the mean daily uptime for the network computed as a mean of the percentage of total daily active hours for all devices in the network. Note that the computation considers both online and offline devices in the network with offline devices recorded as 0% uptime. The manufacturer recommends at least 85% daily uptime per device.

Based on figure 7, there was a decline in both uptime and total entries recorded across the network between 27 and 30 December. The manufacturer acknowledged the issue experienced across the network was due to high latency in IoT SIM card roaming. Since all the devices in the network are equipped with international IoT simcards, latency issues primarily result from home-routed roaming, where data from the devices in Nairobi is transmitted back to the SIM card operator's network before reaching the device cloud storage used by the device manufacturer. Besides, it was also noted during maintenance that the IoT SIM card roaming profiles in selected regions of the city defaulted to suboptimal network choice with weak signals forcing data transmission retries leading to failure in some cases.

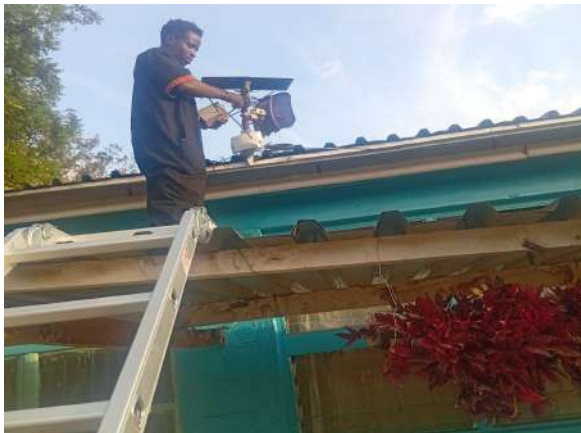
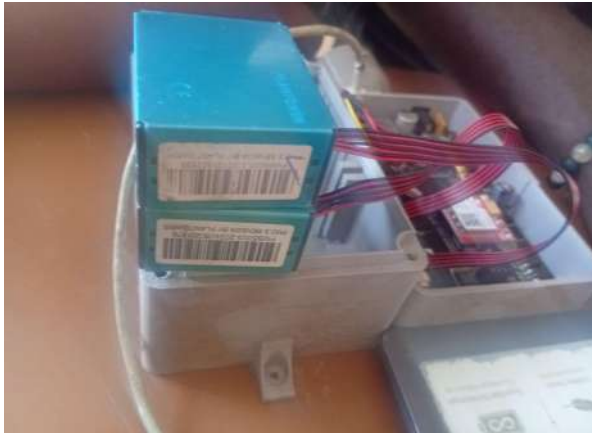
SITE SPECIFICATIONS	
SITE NAME	Tom Mboya Primary Sch Dandora Phase3
SITE NUMBER/ID	AQ_G5400
MAINTENANCE DETAILS:	
DATE: 23/11/2025	
REPORTED ISSUE	One Sensor failure
INTERVENTIONS & ACTION	Sensor Replacement
STATUS	Battery, GSM, Roaming network (Safaricom), and firmware were all confirmed as OKAY. Device posted well on thingspeak
SITE PHOTOGRAPHS

RECOMMENDATIONS:	
Consider Firmware Update to 42.76 in the next visit.

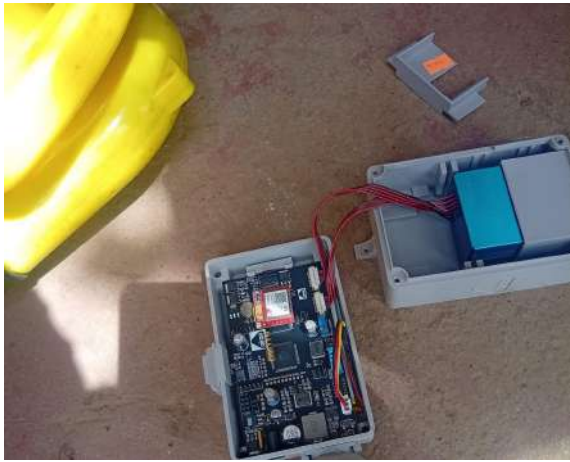
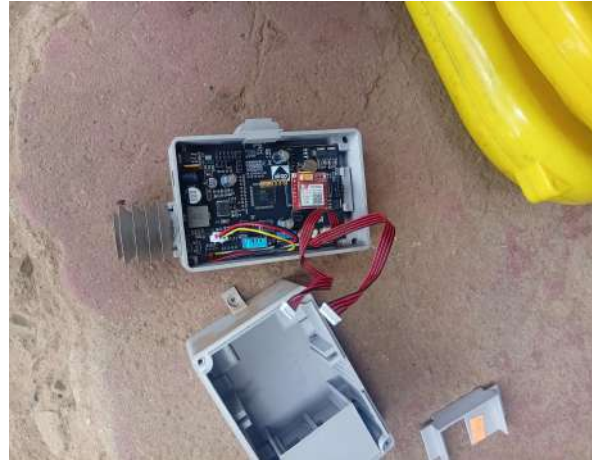
SITE SPECIFICATIONS	
SITE NAME	Hon John Njoroge Primary School
SITE NUMBER/ID	AQ_G5386
MAINTENANCE DETAILS:	
DATE: 23/11/2025	
REPORTED ISSUE	One Sensor failure
INTERVENTIONS & ACTION	Sensor Replacement
STATUS	Battery, GSM, Roaming network (Safaricom), and firmware were all confirmed as OKAY. Device posted well on thingspeak

Consider Firmware Update to 42.76 in the next visit.

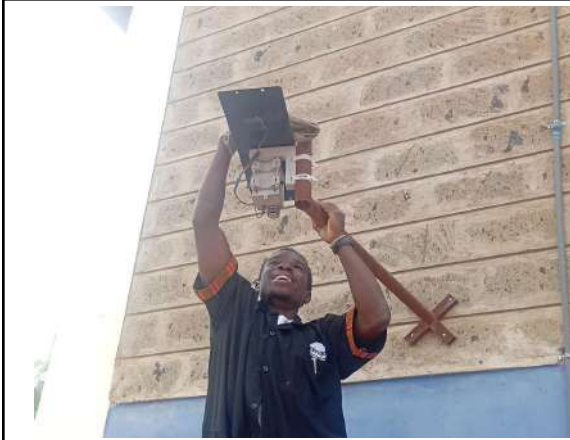
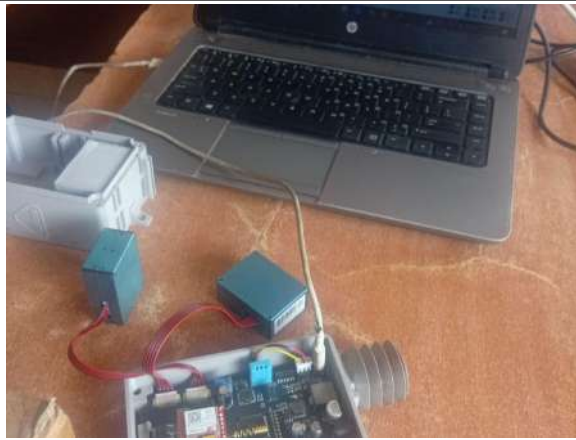
SITE SPECIFICATIONS	
SITE NAME	Mukuru Community Centre
SITE NUMBER/ID	AQ_G5407
MAINTENANCE DETAILS:	
DATE: 23/11/2025	
REPORTED ISSUE	SD Card & 1 Sensor
INTERVENTIONS & ACTION	SD Card & sensor replaced, Firmware Update to 42.75, GSM Voltage 3.5V to 4.2V\$.
STATUS	Battery, GSM, Roaming network (Safaricom), and firmware were all confirmed as OKAY. Device posted well on thingspeak
SITE PHOTOGRAPHS

RECOMMENDATIONS: Noted solar shading issue for next visit.

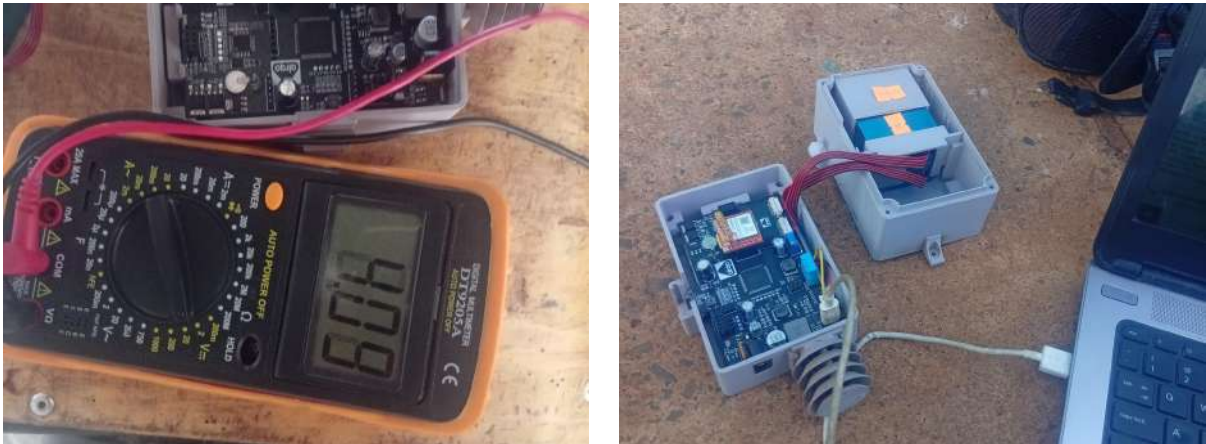
SITE SPECIFICATIONS	
SITE NAME	Langata Road Primary School
SITE NUMBER/ID	AQ_G5411
MAINTENANCE DETAILS:	
DATE: 23/11/2025	
REPORTED ISSUE	SD card issue and difficulty with roaming network selection (Kencel as default)
INTERVENTIONS & ACTION	Firmware Update to 42.75, SD Card replaced & Network defaulted to Safaricom
STATUS	The battery and GSM Module were functioning correctly. The device connected successfully on Thingspeak.
SITE PHOTOGRAPHS

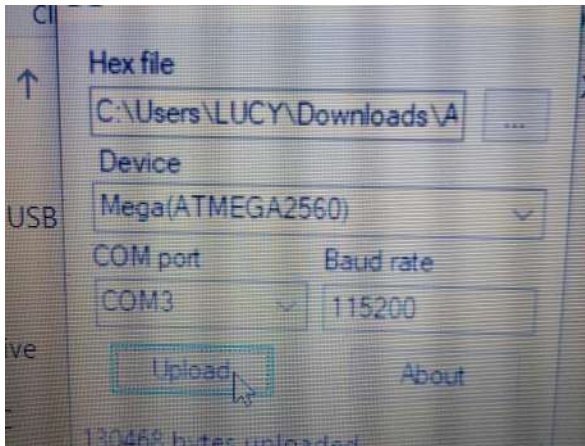
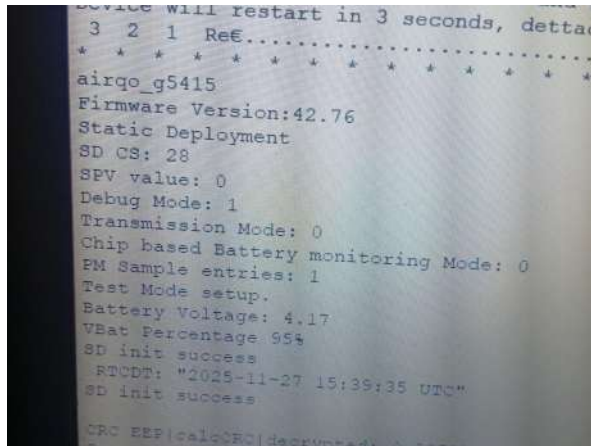
SITE SPECIFICATIONS	
SITE NAME	Westlands Primary School
SITE NUMBER/ID	AQ_G5415
MAINTENANCE DETAILS:	
DATE: 23/11/2025	
REPORTED ISSUE	Roaming network issue (device defaulted to Kencell). GSM Voltage at 3.75
INTERVENTIONS & ACTION	The roaming network setting was set to a default of Safaricom. The firmware updated to the v42.76 version. GSM Voltage adjusted to 4.20V. SD card formatting was successful, and the device posted data successfully
STATUS	Battery, SD Card were noted okay.

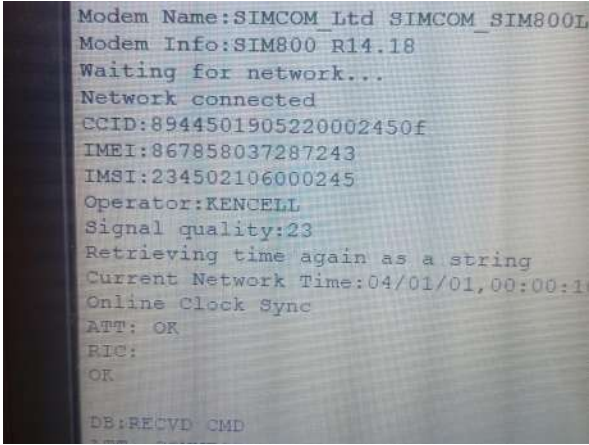
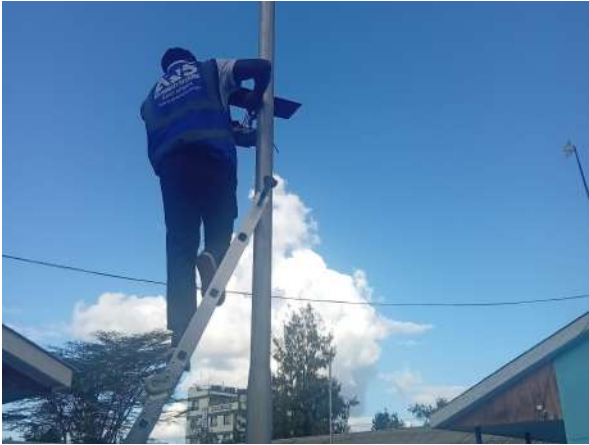
DATE: 23/11/2025	
REPORTED ISSUE	Roaming network issue (device defaulted to Kencell).
INTERVENTIONS & ACTION	The roaming network setting was set to a default of Safaricom. The firmware updated to the v42.76 version. SD card formatting was successful, and the device posted data successfully
STATUS	Battery, SD Card, and GSM Voltage (confirmed at 4.24V) were noted okay.
SITE PHOTOGRAPHS

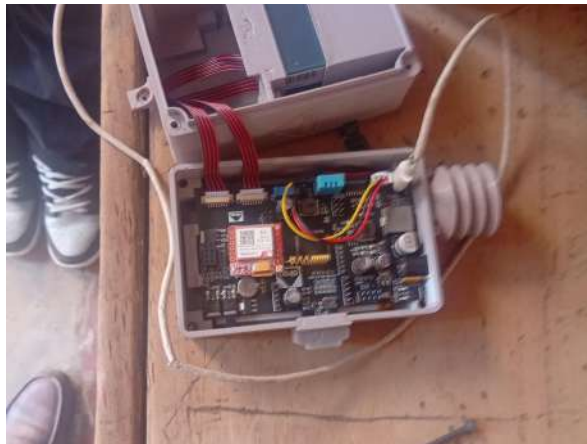
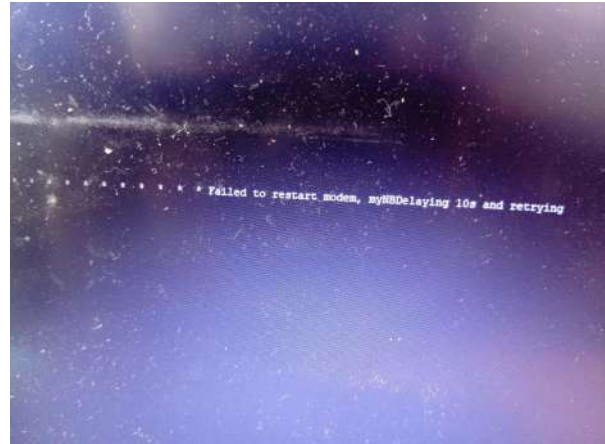
SITE SPECIFICATIONS	
SITE NAME	Ushirika Primary School
SITE NUMBER/ID	AQ_G5394
MAINTENANCE DETAILS:	
DATE: 23/11/2025	
REPORTED ISSUE	SD card issue and difficulty with roaming network selection (Kencel as default).
INTERVENTIONS & ACTION	The SD card was replaced. The roaming network was changed from Kencel to a default of Safaricom network
STATUS	Battery, GSM Module (Voltage 4.2V), and firmware (42.75) were verified as fully functional.
SITE PHOTOGRAPHS

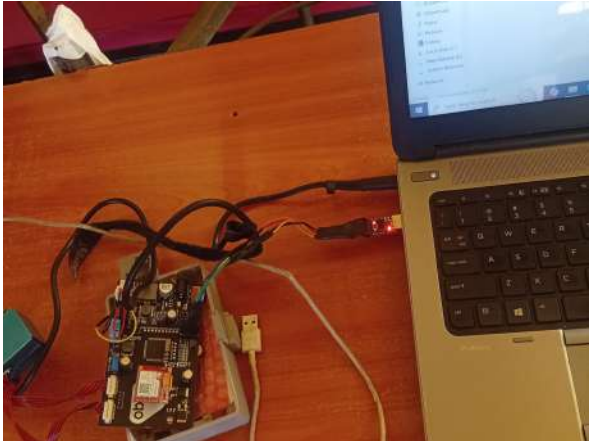
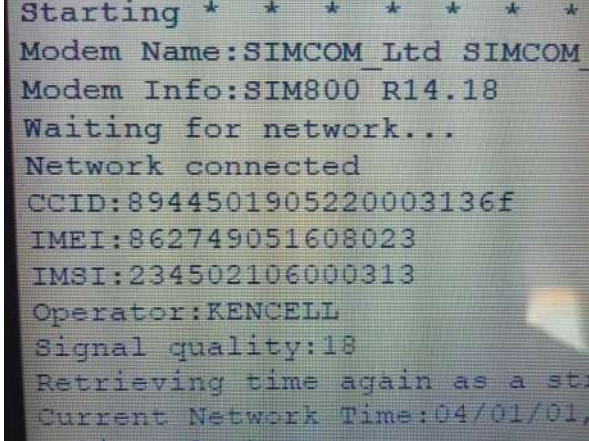
SITE SPECIFICATIONS	
SITE NAME	Nairobi River Primary School
SITE NUMBER/ID	AQ_G5287
MAINTENANCE DETAILS:	
DATE: 23/11/2025	
REPORTED ISSUE	Inconsistent data posting, linked to a default Kencel roaming profile (Network).
INTERVENTIONS & ACTION	Firmware Update to v42.75, and the GSM Voltage was confirmed at 4.19V. The roaming network was set default to Safaricom.
STATUS	Battery and SD card were verified as functional
SITE PHOTOGRAPHS

RECOMMENDATIONS: SIM network signal strength is low. Use local SIM (Safaricom)

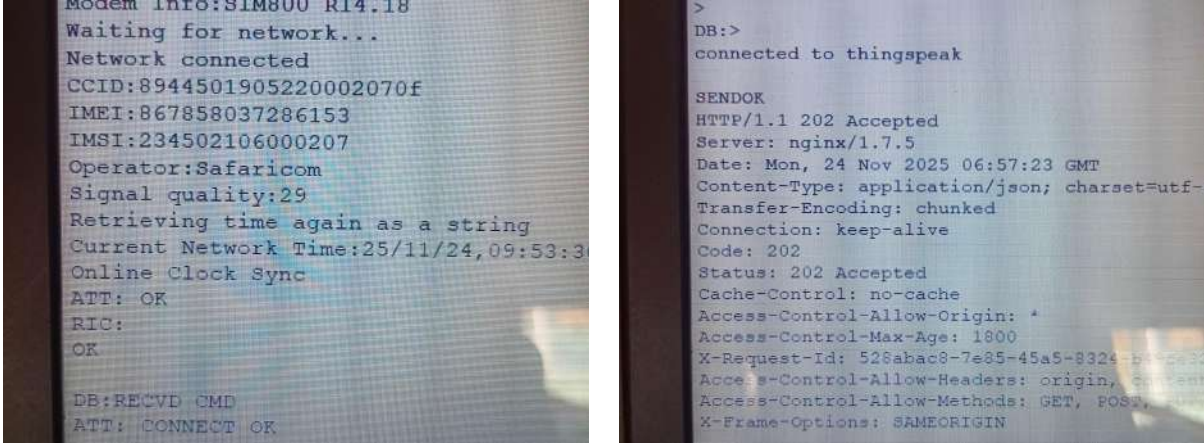
SITE SPECIFICATIONS	
SITE NAME	Dr. Mwenje Primary School
SITE NUMBER/ID	AQ_G5390
MAINTENANCE DETAILS:	
DATE: 23/11/2025	
REPORTED ISSUE	The device had been removed following a security alert concerning its safety
INTERVENTIONS & ACTION	All components were verified as functional upon inspection.

STATUS	The device was successfully recovered by the maintenance team. Firmware updated to v42.75. Devices are mounted at a different location, with a Count Official facilitating the identification of the secure new site.
SITE PHOTOGRAPHS

RECOMMENDATIONS: SIM network profile swap

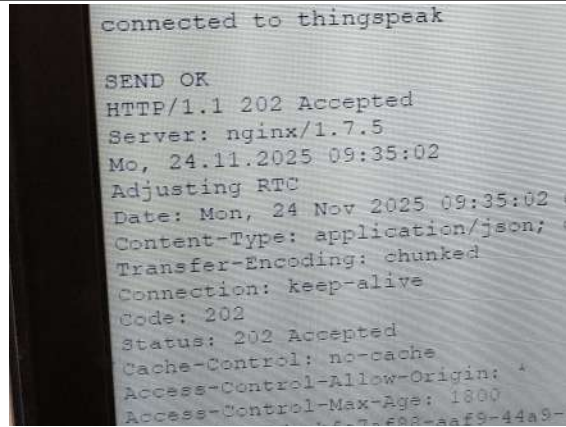
SITE SPECIFICATIONS	
SITE NAME	Tumaini Primary School
SITE NUMBER/ID	AQ_G5402
MAINTENANCE DETAILS:	
DATE: 23/11/2025	
REPORTED ISSUE	Communication issue due to the Roaming Network defaulting to Kencell.
INTERVENTIONS & ACTION	The roaming network was permanently changed to Safaricom. The firmware was updated to the latest v42.76 version with EEPROM protection. The SD card was successfully formatted and operated correctly.
STATUS	Battery, SD Card, and GSM Voltage (confirmed at 4.24V.) noted as okay. Device posted successfully.
SITE PHOTOGRAPHS

RECOMMENDATIONS:
[SD card format, firmware update](#)

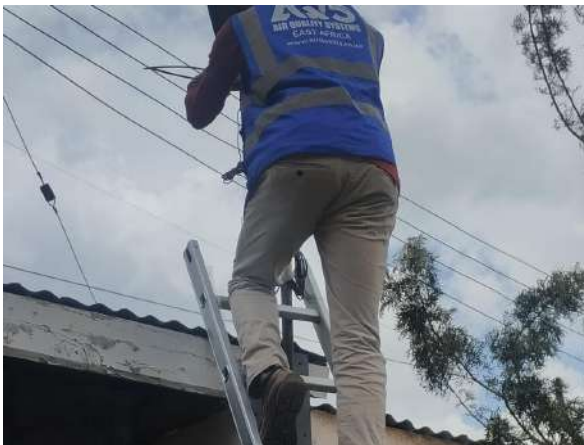
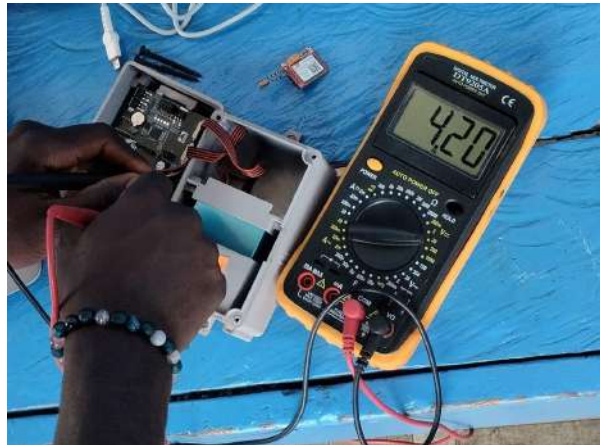
SITE SPECIFICATIONS	
SITE NAME	Njiru Level 4 Hospital.
SITE NUMBER/ID	AQ_G5403
MAINTENANCE DETAILS:	
DATE: 23/11/2025	
REPORTED ISSUE	Intermittent Transmission or persistent communication failure.
INTERVENTIONS & ACTION	The communication issue was resolved by setting the roaming network from Kencel to the Safaricom network, enabling stable data posting.
STATUS	Battery, GSM Module, and firmware were verified okay.

Local SIM

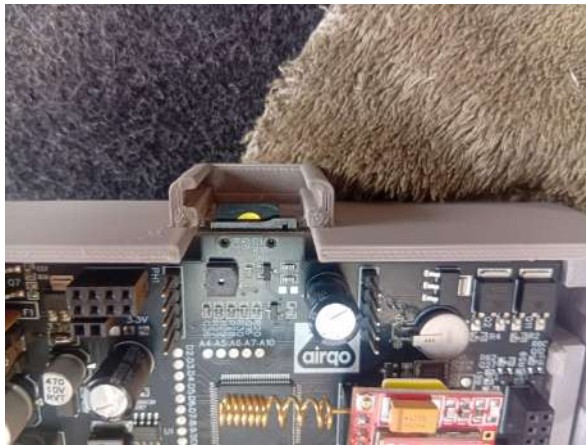
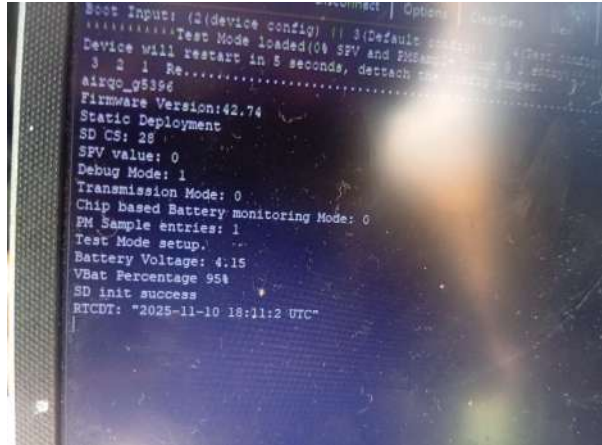
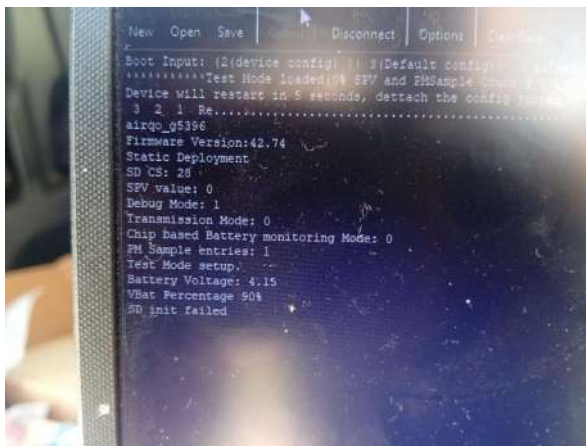
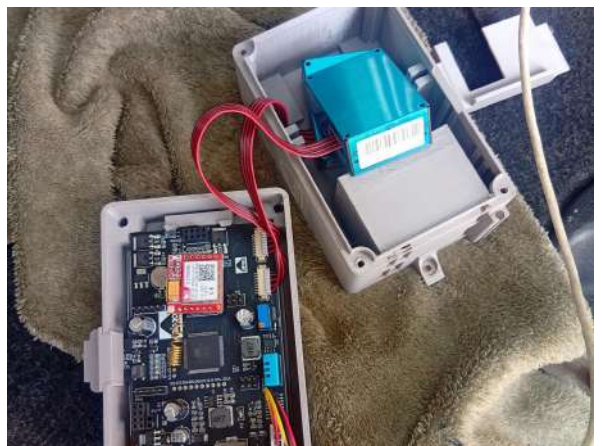
SITE NAME	Githurai Secondary School
SITE NUMBER/ID	AQ_G5396
MAINTENANCE DETAILS:	
DATE: 23/11/2025	
REPORTED ISSUE	SD card issue and a critical communication failure.
INTERVENTIONS & ACTION	A new Safaricom SIM card was installed and Firmware updated to V42.76
STATUS	The battery, GSM Module, and firmware were operating correctly.

SD Card formatting or swap

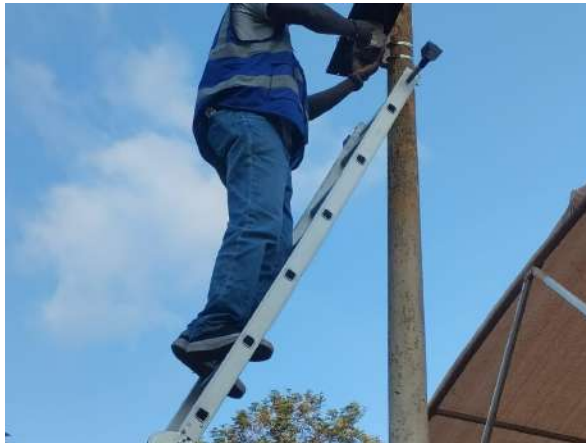
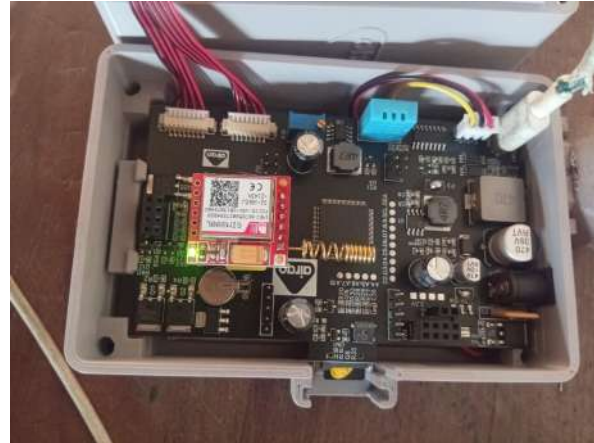
SITE SPECIFICATIONS	
SITE NAME	Lavington Primary School
SITE NUMBER/ID	AQ_G5408
MAINTENANCE DETAILS:	
DATE: 23/11/2025	
REPORTED ISSUE	SD card was physically missing and there was Network Jam.(Network Roaming profile on Kencel)
INTERVENTIONS & ACTION	The roaming network was set to a default of Safaricom, and the latest Firmware Update to v42.75 was applied.
STATUS	Battery and GSM Voltage (4.2V) were confirmed as stable. The device successfully posted data on Thingspeak.

Persistence of the poor network and communication of the device can be solved by purchasing Local Sim Card (Safaricom) to reduce the possibility of roaming to Kencel especially in an area with low local network.

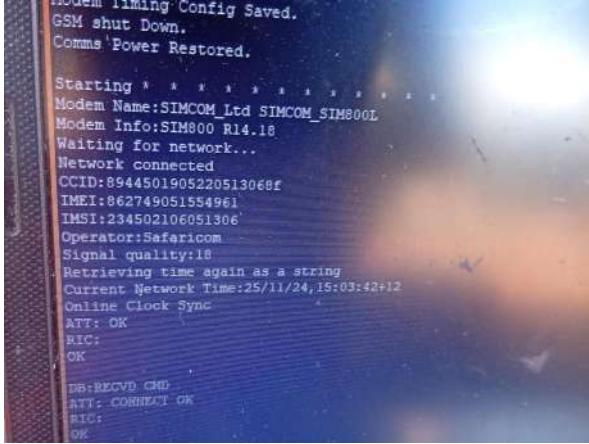
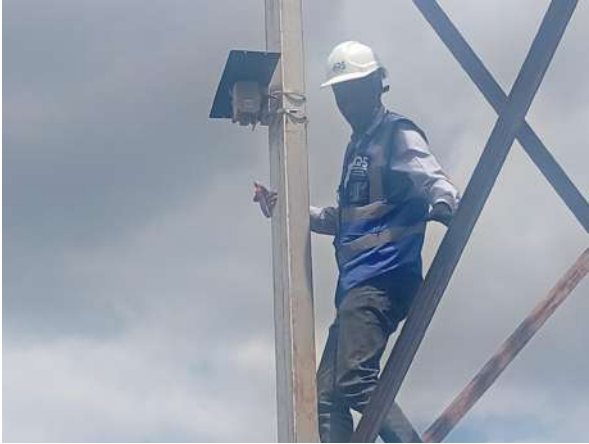
SITE SPECIFICATIONS	
SITE NAME	Mutuini Primary School
SITE NUMBER/ID	AQ_G5372
MAINTENANCE DETAILS:	
DATE: 23/11/2025	
REPORTED ISSUE	The device had stopped posting for almost 100 days due to a configuration transmission failure
INTERVENTIONS & ACTION	The device was reprogrammed to restore configuration integrity and successfully posted data. Crucially, the firmware was updated

to version 42.76, which incorporates a third-tier protection capability for the EEPROM to prevent future transmission configuration failures
--	--

RECOMMENDATIONS:
 Monitor the Up-time or interference on the device in case of any configuration failure. The experienced case is common in network restricted areas (Proximity to high security areas).

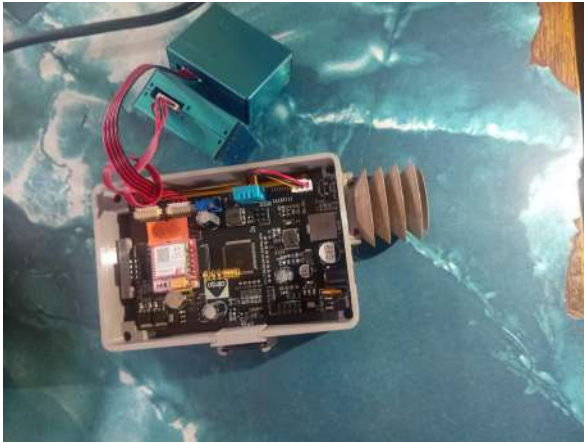
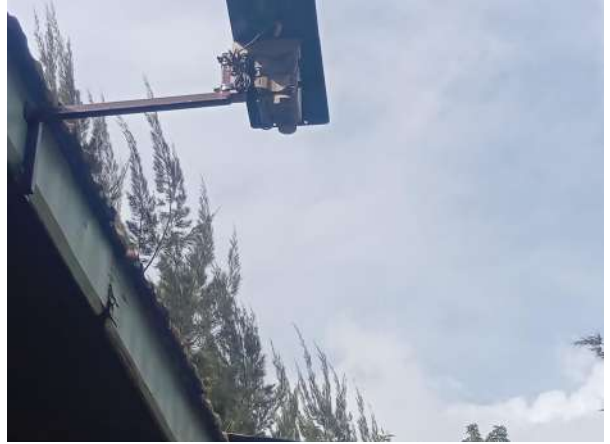
REPORTED ISSUE	SD Card failure and Sensor malfunction
----------------	--

INTERVENTIONS & ACTION	The faulty SD card and Sensor were replaced with new units.
------------------------	---

STATUS	Battery, GSM Module, Roaming network (Safaricom) and current firmware (V42.75) were functional. Post-replacement, the device successfully initiated communication and posted data on Thingspeak platform
--------	--

RECOMMENDATIONS:
 Monitor the Up-time of the device and Roaming network

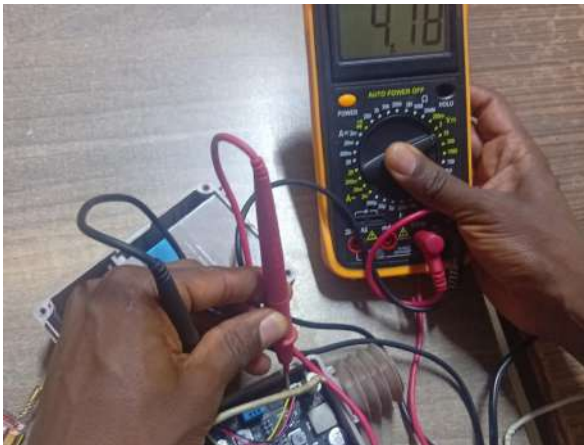
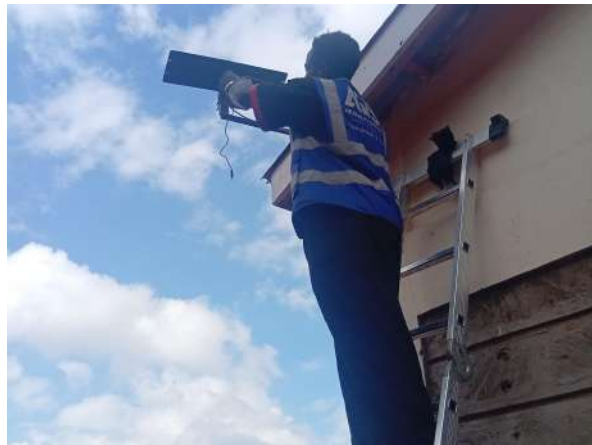
DATE: 23/11/2025	
CURRENT REPORTED ISSUE	Inconsistent data readings (Uptime), Sensors malfunction and SD CARD failure.
INTERVENTIONS & ACTION	Two sensors and SD card were replaced. The firmware was updated to the latest v42.76 version.
STATUS	Battery and GSM were functional; GSM Voltage confirmed at 4.19V. Roaming network automatically picked Safaricom.

RECOMMENDATIONS:
 Monitor the Up-time of the device

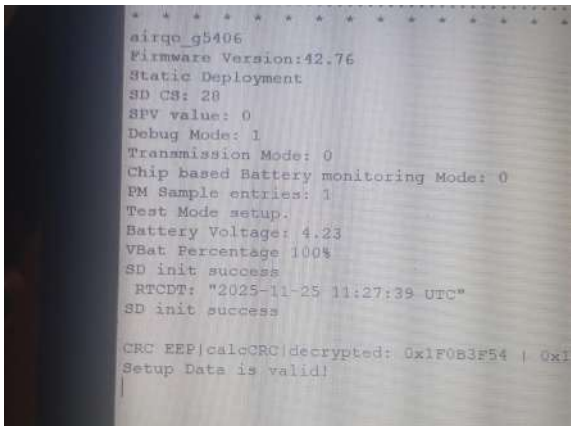
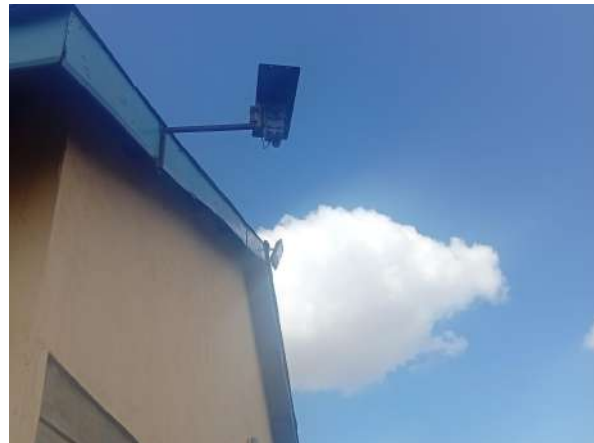
SITE SPECIFICATIONS	
SITE NAME	Kasarani Primary School
SITE NUMBER/ID	AQ_G5406
MAINTENANCE DETAILS:	
DATE: 23/11/2025	
CURRENT REPORTED ISSUE	Poor uptime & SD card Failure
INTERVENTIONS & ACTION	SD Card formatted, Firmware 42.76.
STATUS	Bat, GSM Voltage 4.2 Roaming network is Safcom GSM okay.

Monitor the uptime of the device

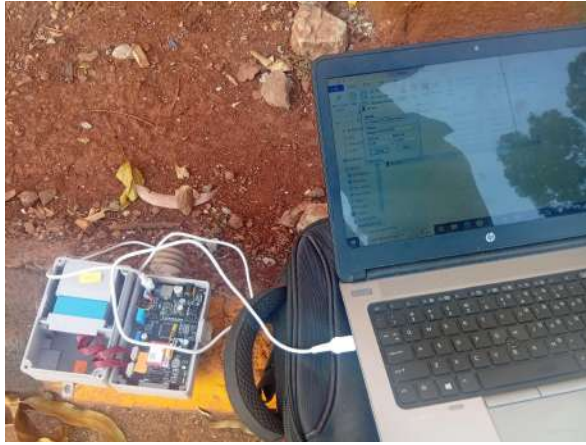
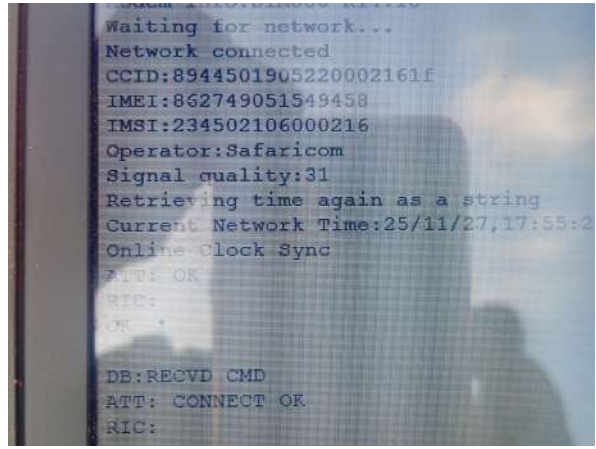
SITE SPECIFICATIONS	
SITE NAME	NEW Kuhumbuini Primary Sch
SITE NUMBER/ID	AQ_G5384
MAINTENANCE DETAILS:	
DATE: 23/11/2025	
CURRENT REPORTED ISSUE	Poor uptime & SD card Failure
INTERVENTIONS & ACTION	SD Card formatted, Firmware 42.76.

Monitor the Up-time of the device

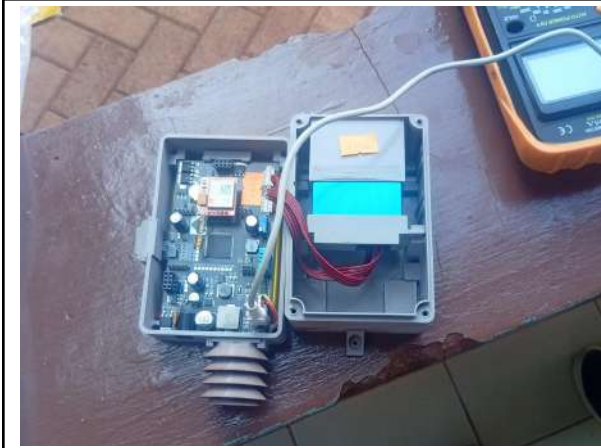
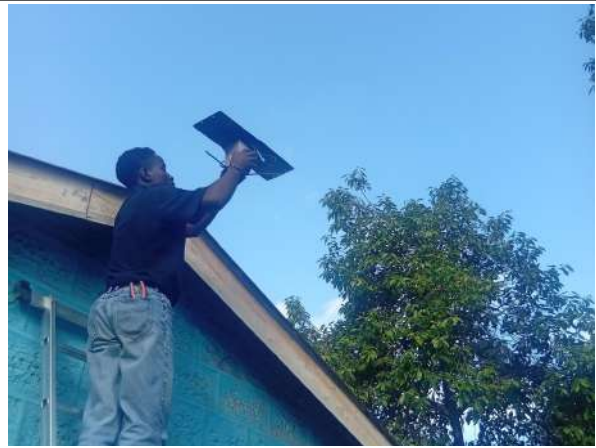
SITE SPECIFICATIONS	
SITE NAME	Karura Forest Primary Sch
SITE NUMBER/ID	AQ_G5381
MAINTENANCE DETAILS:	
DATE: 23/11/2025	
CURRENT REPORTED ISSUE	Poor uptime & SD card Failure
INTERVENTIONS & ACTION	SD Card formatted, Firmware 42.76.
STATUS	Bat, GSM Voltage 4.2 Roaming network is Safcom GSM okay.
SITE PHOTOGRAPHS

RECOMMENDATIONS:
 Monitor the Up-time of the device

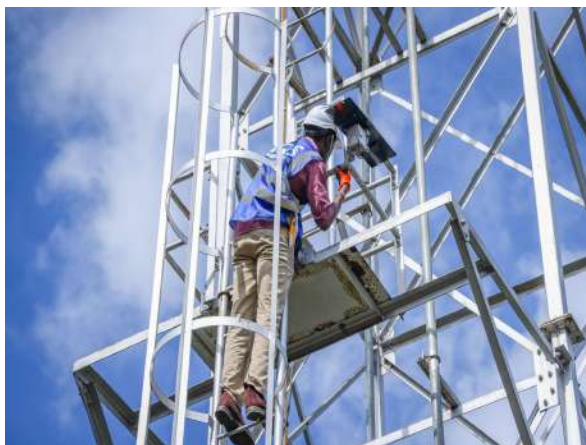
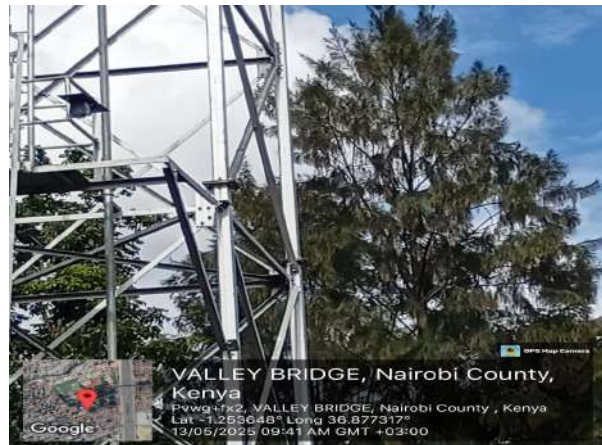
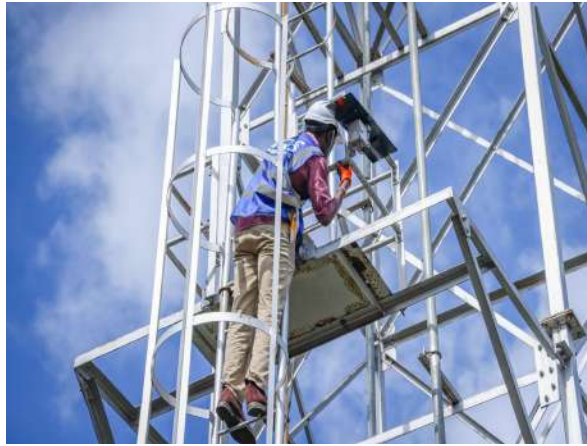
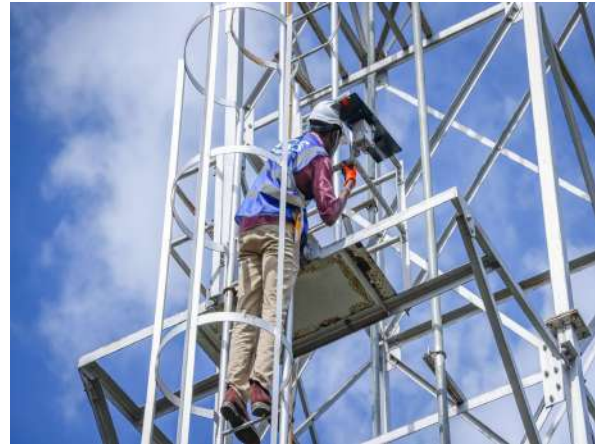
SITE SPECIFICATIONS	
SITE NAME	Valley Bridge Primary Sch
SITE NUMBER/ID	AQ_G5389
MAINTENANCE DETAILS:	
DATE: 23/11/2025	
CURRENT REPORTED ISSUE	Poor uptime & SD card Failure
INTERVENTIONS & ACTION	SD Card formatted, Firmware 42.76.
STATUS	Bat, GSM Voltage 4.2 Roaming network is Safcom GSM okay.

RECOMMENDATIONS:
 Monitor the Up-time of the device

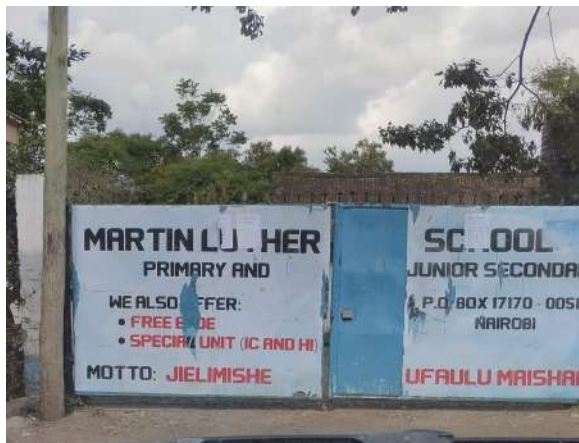
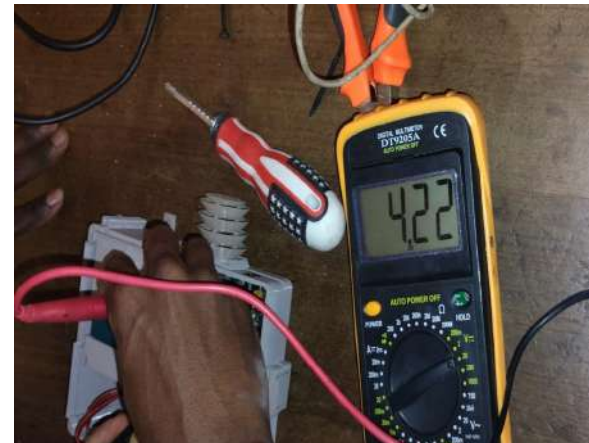
SITE SPECIFICATIONS	
SITE NAME	Martin Luther Primary Sch
SITE NUMBER/ID	AQ_G5323
MAINTENANCE DETAILS:	
DATE: 23/11/2025	
CURRENT REPORTED ISSUE	Poor uptime & SD card Failure
INTERVENTIONS & ACTION	SD Card formatted, Firmware 42.76.
STATUS	Bat, SD card (though formatted) GSM Voltage to 4.24, Roaming network is Safcom & GSM okay.

RECOMMENDATIONS:
 Monitor the Up-time of the device

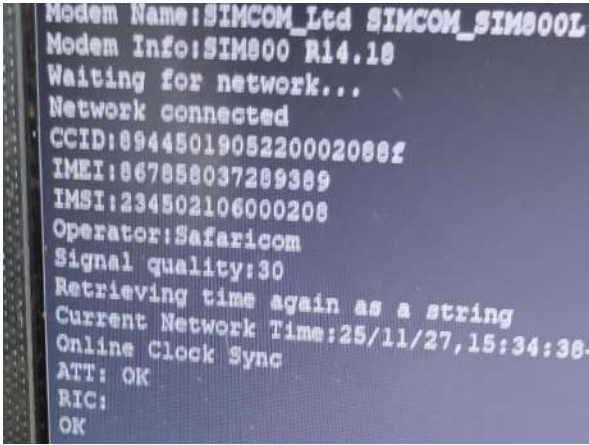
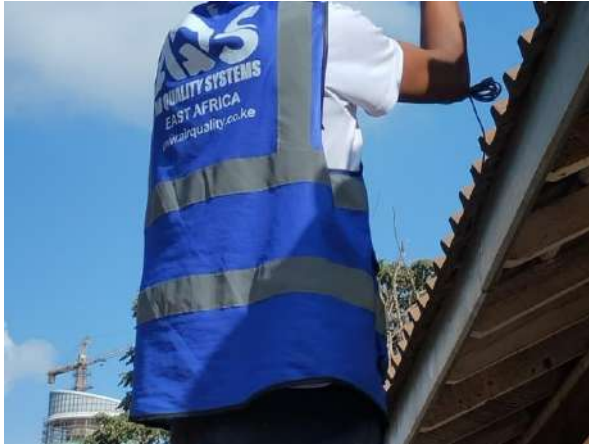
MAINTENANCE DETAILS:	
DATE: 23/11/2025	
CURRENT REPORTED ISSUE	Poor uptime
INTERVENTIONS & ACTION	SD card replaced, Roaming default to Safaricom.& Firmware updated to 42.76
STATUS	Bat, SD card and GSM Voltage at 4.24v & GSM okay
SITE PHOTOGRAPHS

RECOMMENDATIONS:	
Monitor the Up-time of the device

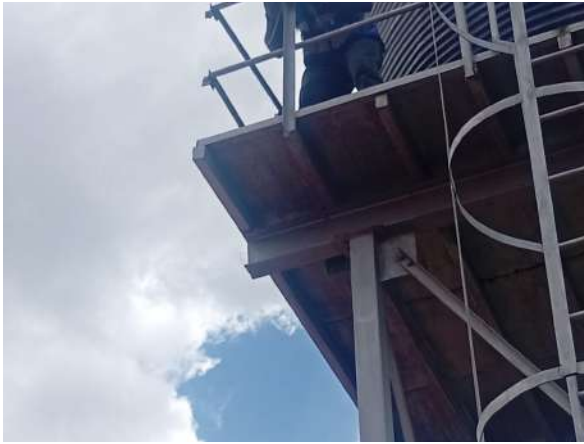
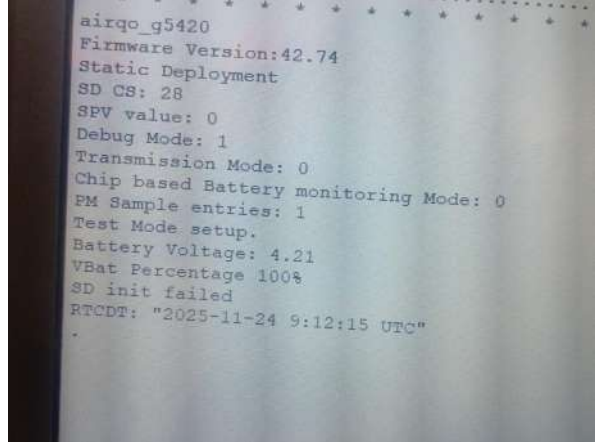
SITE SPECIFICATIONS	
SITE NAME	Mbagathi Road Primary School
SITE NUMBER/ID	AQ_G5420
MAINTENANCE DETAILS:	
DATE: 23/11/2025	
CURRENT REPORTED ISSUE	Poor uptime & Kencel Roaming
INTERVENTIONS & ACTION	Firmware 42.76, SD card formatted.
STATUS	Bat, GSM Voltage at 4.19v
SITE PHOTOGRAPHS

RECOMMENDATIONS:
[Monitor the Up-time of the device](#)

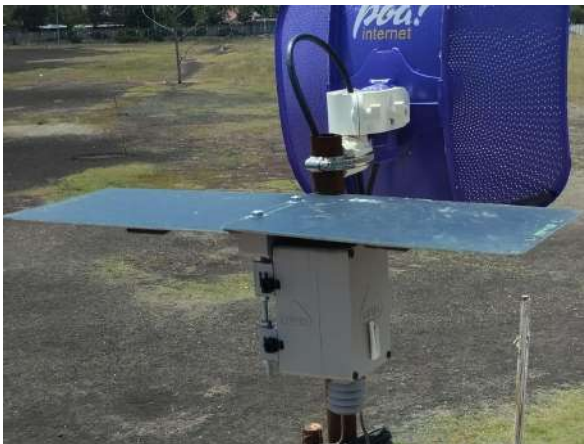
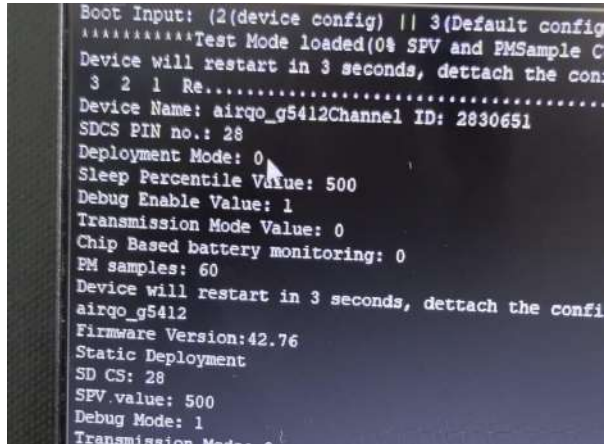
SITE SPECIFICATIONS	
SITE NAME	Manyatta Primary School
SITE NUMBER/ID	AQ_G5413
MAINTENANCE DETAILS:	
DATE: 23/11/2025	
CURRENT REPORTED ISSUE	Poor uptime
INTERVENTIONS & ACTION	SD card replaced, Roaming default to Safaricom. Firmware updated to 42.76
STATUS	Bat, SD card and GSM Voltage at 4.24v & GSM okay

RECOMMENDATIONS: Monitor the Up-time of the device

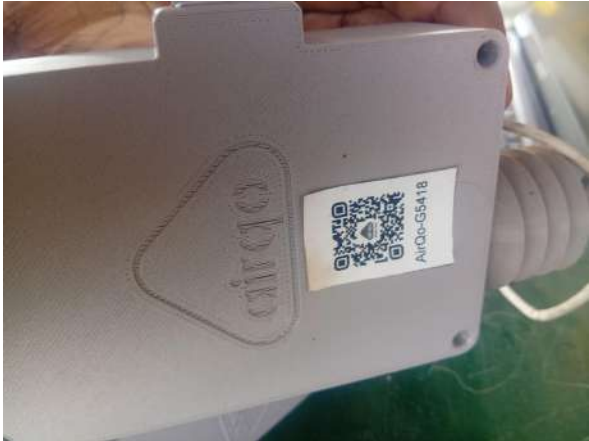
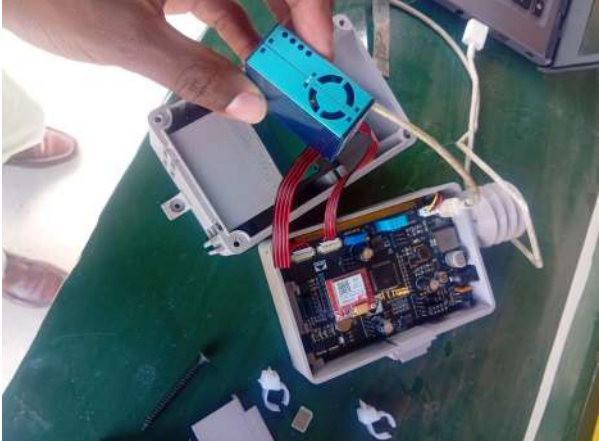
SITE SPECIFICATIONS	
SITE NAME	ST. Mary's Karen Primary Sch
SITE NUMBER/ID	AQ_G5418
MAINTENANCE DETAILS:	
DATE: 23/11/2025	
CURRENT REPORTED ISSUE	Loose Sensor, Low GSM voltage
INTERVENTIONS & ACTION	Sensor connection fixed. GSM 3.89 to 4.23V. Firmware 42.76. Note: Roaming on Kencel though performing well
STATUS	Bat, SD card and GSM Voltage at 4.24v & GSM okay

RECOMMENDATIONS: Monitor the Up-time of the device

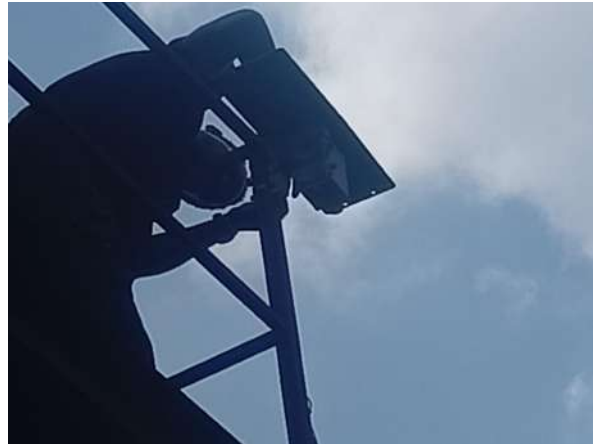
SITE SPECIFICATIONS	
SITE NAME	ST. Georges Primary School
SITE NUMBER/ID	AQ_G5414
MAINTENANCE DETAILS:	
DATE: 23/11/2025	
CURRENT REPORTED ISSUE	Sensor, SD card Failure & Kencel Roaming
INTERVENTIONS & ACTION	Sensor replaced &SD Card formatted and inserted successfully. Firmware 42.76.
STATUS	Bat, GSM Voltage at 4.19v Okay
SITE PHOTOGRAPHS

RECOMMENDATIONS:
[Monitor the Up-time of the device](#)
