Air Quality Systems East Africa

December 2025

Nairobi, Kenya

Executive Summary

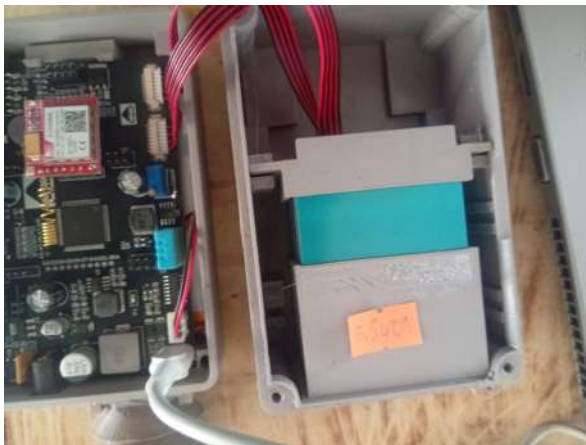
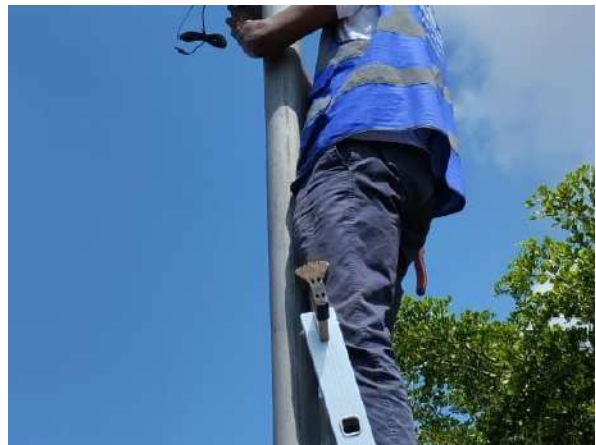
SITE SPECIFICATIONS	
SITE NAME	Uhuru Gardens Primary School
SITE NUMBER/ID	AQ_G5409
MAINTENANCE DETAILS:	
DATE: 23/11/2025	
CURRENT REPORTED ISSUE	SD Card Missing & Kencel Roaming network
INTERVENTIONS & ACTION	SD card inserted. Firmware updated to 42.76. Roaming network default to Safaricom
STATUS	Bat, GSM Voltage at 4.19v Okay

RECOMMENDATIONS:
 Monitor the Up-time of the device

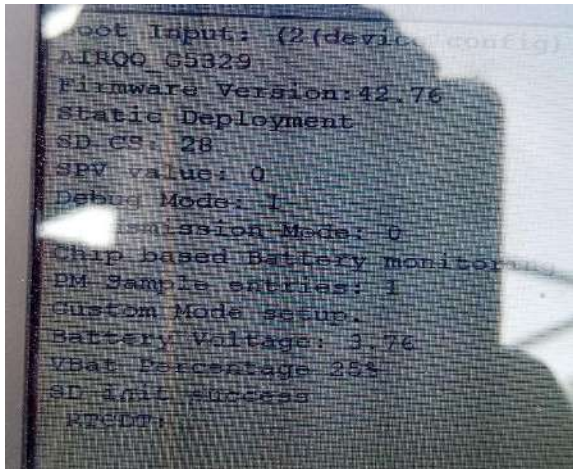
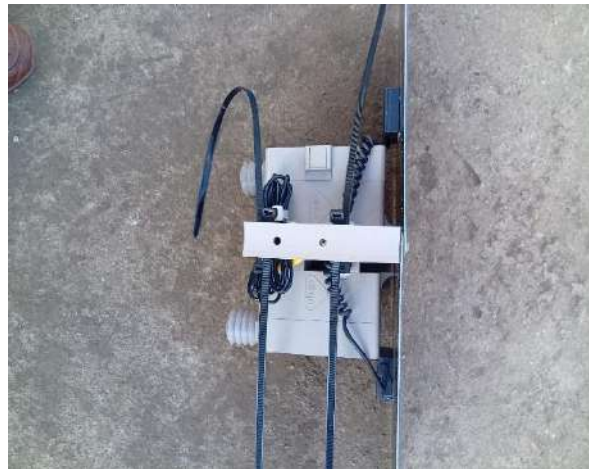
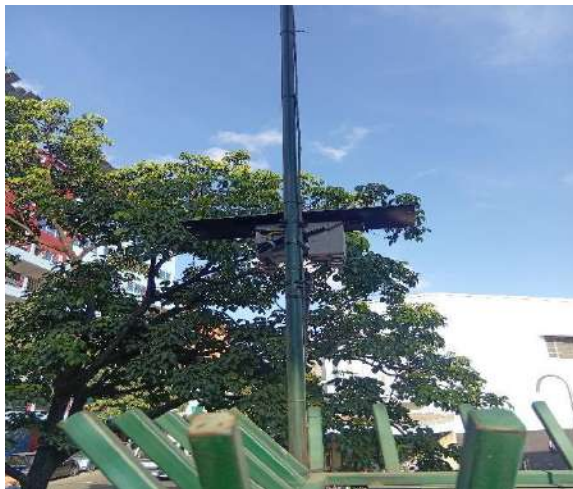
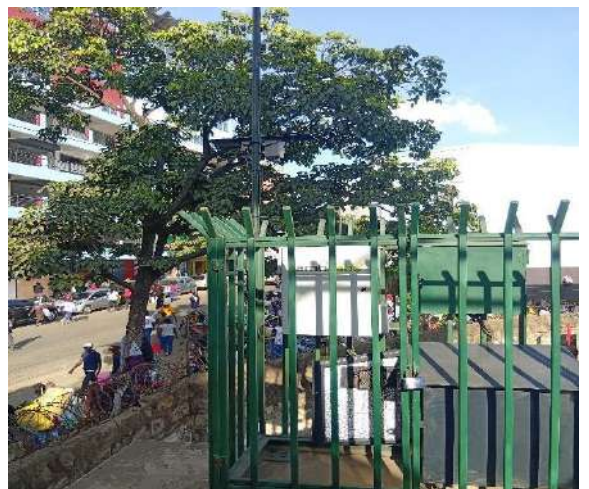
Two sites experienced security issues (vandalism/removal), leading to component replacement at the Fire Station and device recovery/relocation from Hon Dr. Mwenje High School to Heidemarie Primary School.

SITE SPECIFICATIONS	
SITE NAME	Fire Station (Tom Mboya)
SITE NUMBER/ID	AQ_G5399 and AQ_G5399
MAINTENANCE DETAILS:	
DATE: 23/11/2025	
CURRENT REPORTED ISSUE	Devices/Structure Vandalized & SD Card Missing
INTERVENTIONS & ACTION	SD card inserted. Casing, mountings, solar panels replaced. Firmware 42.76.
STATUS	Bat, GSM Voltage at 4.19v Okay

Monitor the uptime of both devices and security of the site
