Air Quality Systems East Africa

December 2025

Nairobi, Kenya

Executive Summary

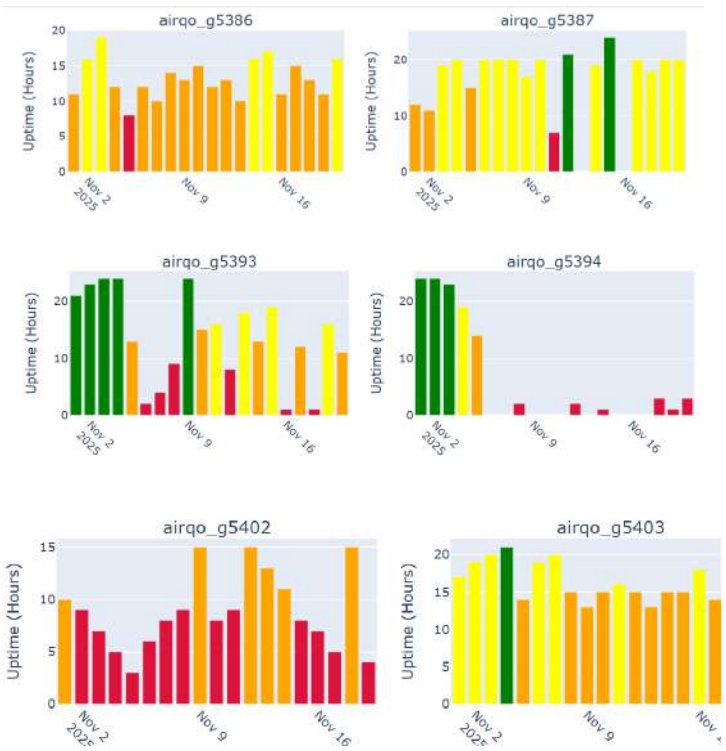
- Daily active hours were used to understand how frequent the devices sent data. Approximately 10 devices had frequent outages with most of them active for at least 15 hours every day.
- Recommendations:
 - Review of the device communication and battery health to understand the frequency of the downtime
 - Firmware updates
 - Battery upgrades

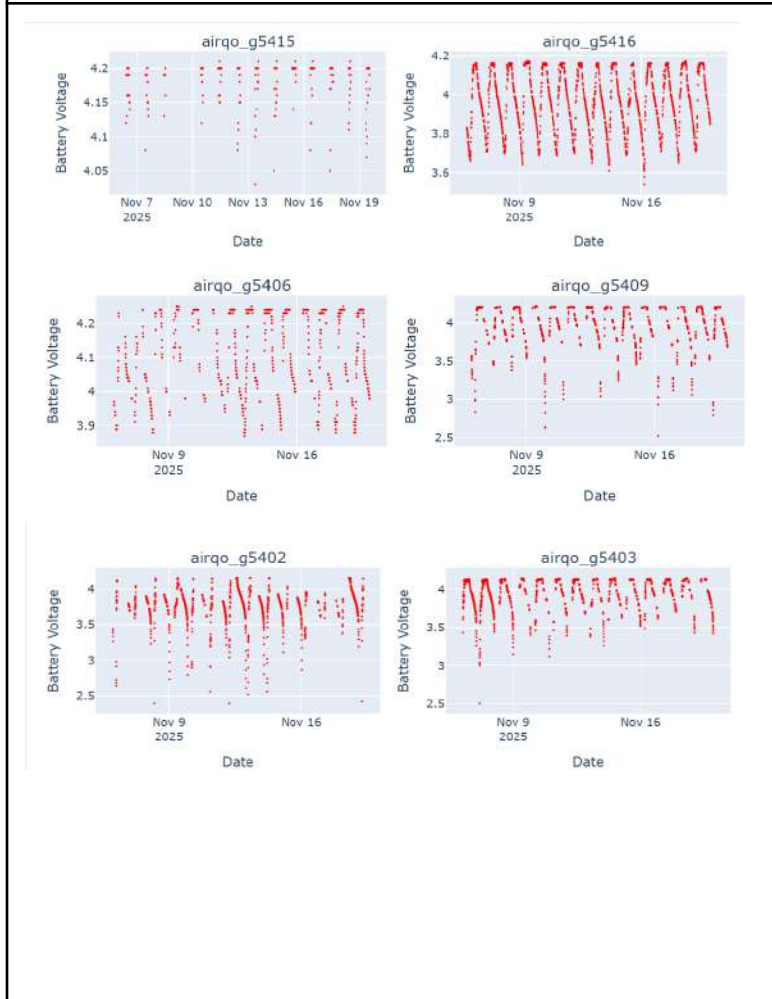
Battery Health

- Several devices were flagged for communication and battery health issues - AIRQO_G5402, AIRQO_G5403, AIRQO_G5406, AIRQO_G5409 and AIRQO_G5415 had poor charge and discharge patterns. Issues related to solar charging or battery life.
- Recommendations:
 - Solar or battery check and replacement
 - GSM test and rectification for communication issues
 - Firmware update

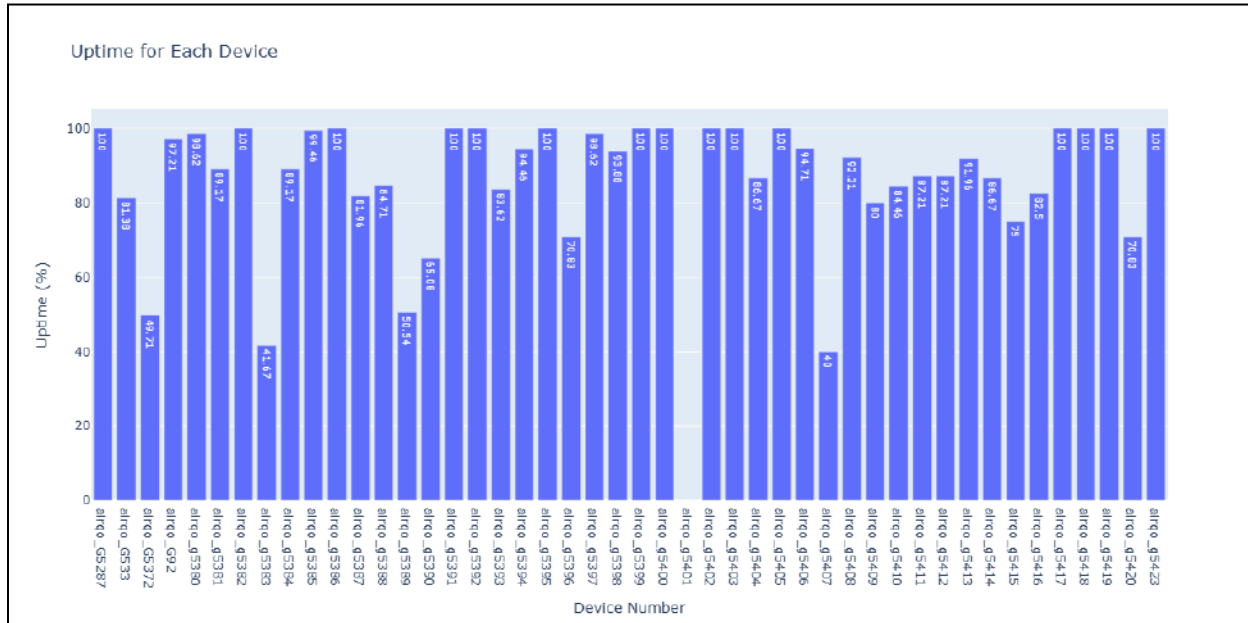
Figure 3. Network uptime trends after maintenance. This figure illustrates the device uptime two weeks after maintenance as a function of hours of the day with a record of entries transmitted by the device. Note that only one device in the network remained offline after maintenance due to location access restrictions.

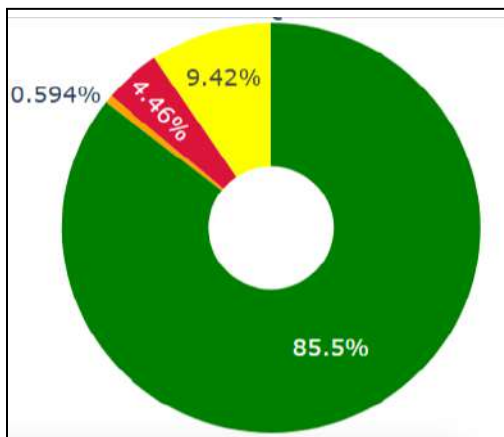
Figure 4a. Network sensor health

- Improved battery performance with over 90% of the network having optimal performance in relation to charge and discharge status of the batteries.
- Over 88% average network uptime corresponding to at least 85% data availability.
- High intra-sensor correlation and low error margins with over 85% of the network having ideal sensor health (error margin less than 5ug/m3 and correlation above 98.5%)
- The new firmware update improves overall battery performance and device uptime. Firmware update with 100% SPV setting leads to reduction in hourly data points. Observed drop from over 40 to 20 data points reported per hour.
- Only 1 device remained offline because of a restricted site access issue.

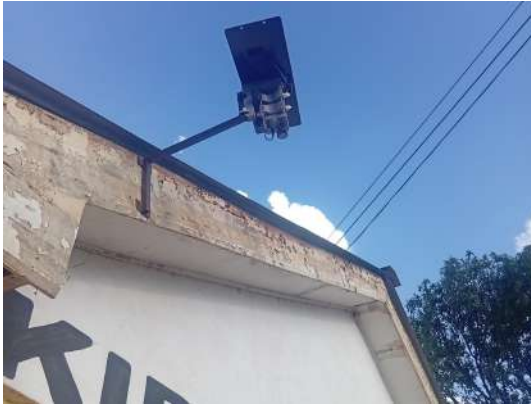
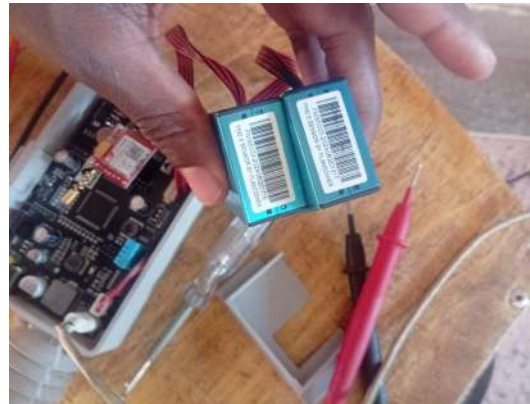
SITE SPECIFICATIONS	
SITE NAME	Ayany Primary School
SITE NUMBER/ID	AQ_G5404
MAINTENANCE DETAILS:	
DATE: 23/11/2025	
REPORTED ISSUE	SD card issue and network
INTERVENTIONS & ACTION	Firmware Update to 42.75, SD Card replaced
STATUS	The battery and GSM Module were functioning correctly. The roaming network defaulted to Safaricom. The device connected successfully on Thingspeak.

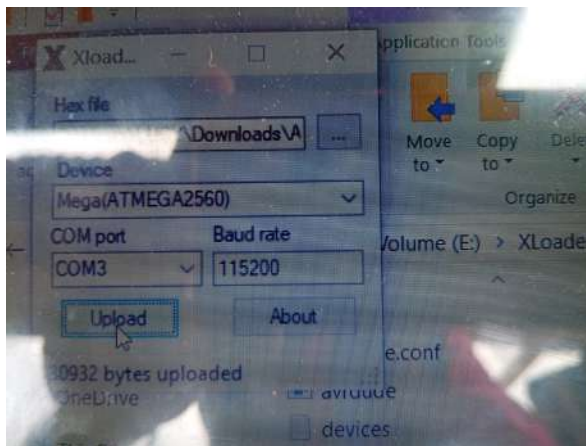
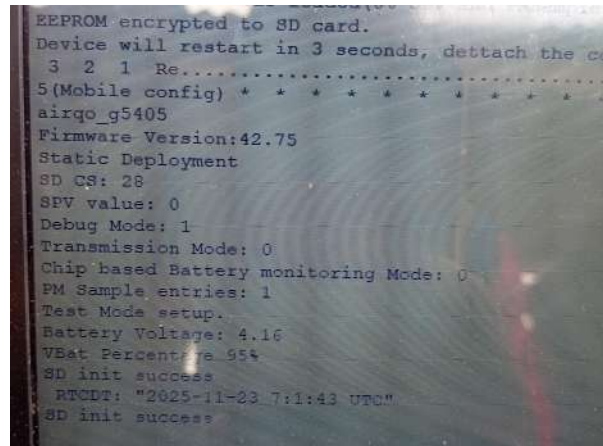
SITE SPECIFICATIONS	
SITE NAME	Thawabu Primary School
SITE NUMBER/ID	AQ_G5405
MAINTENANCE DETAILS:	
DATE: 23/11/2025	
REPORTED ISSUE	SD card issue and difficulty with roaming network selection (Kencel as default)
INTERVENTIONS & ACTION	The device received a comprehensive Firmware Update to V42.75. The GSM Voltage was adjusted to 4.20V, and the roaming network set to a default of Safaricom.
STATUS	The battery and GSM Module were functioning correctly.

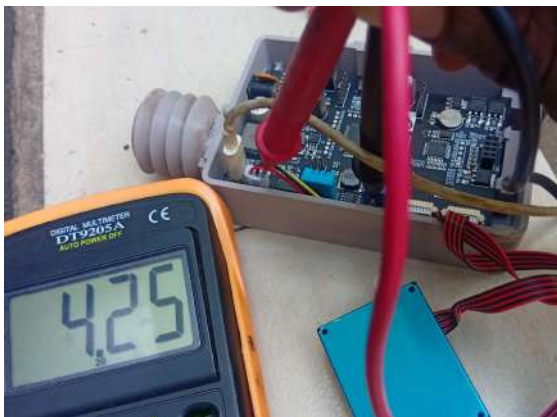
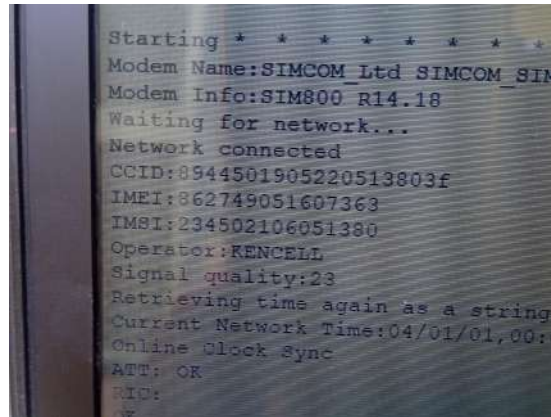
SITE SPECIFICATIONS	
SITE NAME	Buruburu 1 Primary School
SITE NUMBER/ID	AQ_G533
MAINTENANCE DETAILS:	
DATE: 23/11/2025	
REPORTED ISSUE	Inconsistent data posting, linked to a default Kencel roaming profile (Network).
INTERVENTIONS & ACTION	Firmware Update to v42.75, and the GSM Voltage was confirmed at 4.19V. The roaming network was set default to Safaricom.
STATUS	Battery and SD card were verified as functional

RECOMMENDATIONS:
[Installation](#)

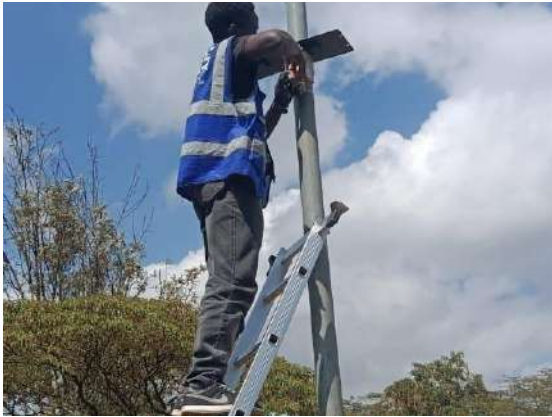
SITE SPECIFICATIONS	
SITE NAME	Tumaini Primary School
SITE NUMBER/ID	AQ_G5402
MAINTENANCE DETAILS:	
DATE: 23/11/2025	
REPORTED ISSUE	Communication issue due to the Roaming Network defaulting to Kencell.
INTERVENTIONS & ACTION	The roaming network was permanently changed to Safaricom. The firmware was updated to the latest v42.76 version with EEPROM protection. The SD card was successfully formatted and operated correctly.
STATUS	Battery, SD Card, and GSM Voltage (confirmed at 4.24V.) noted as okay. Device posted successfully.
SITE PHOTOGRAPHS

RECOMMENDATIONS:
[SD card format, firmware update](#)
